**MEMORANDUM FOR RECORD**

**INDUSTRIAL STORM WATER SITE VISIT**

**SHINE BROTHERS CORPORATION/STORY BOOK PARK  
SPENCER, IA**

**November 20, 2013**

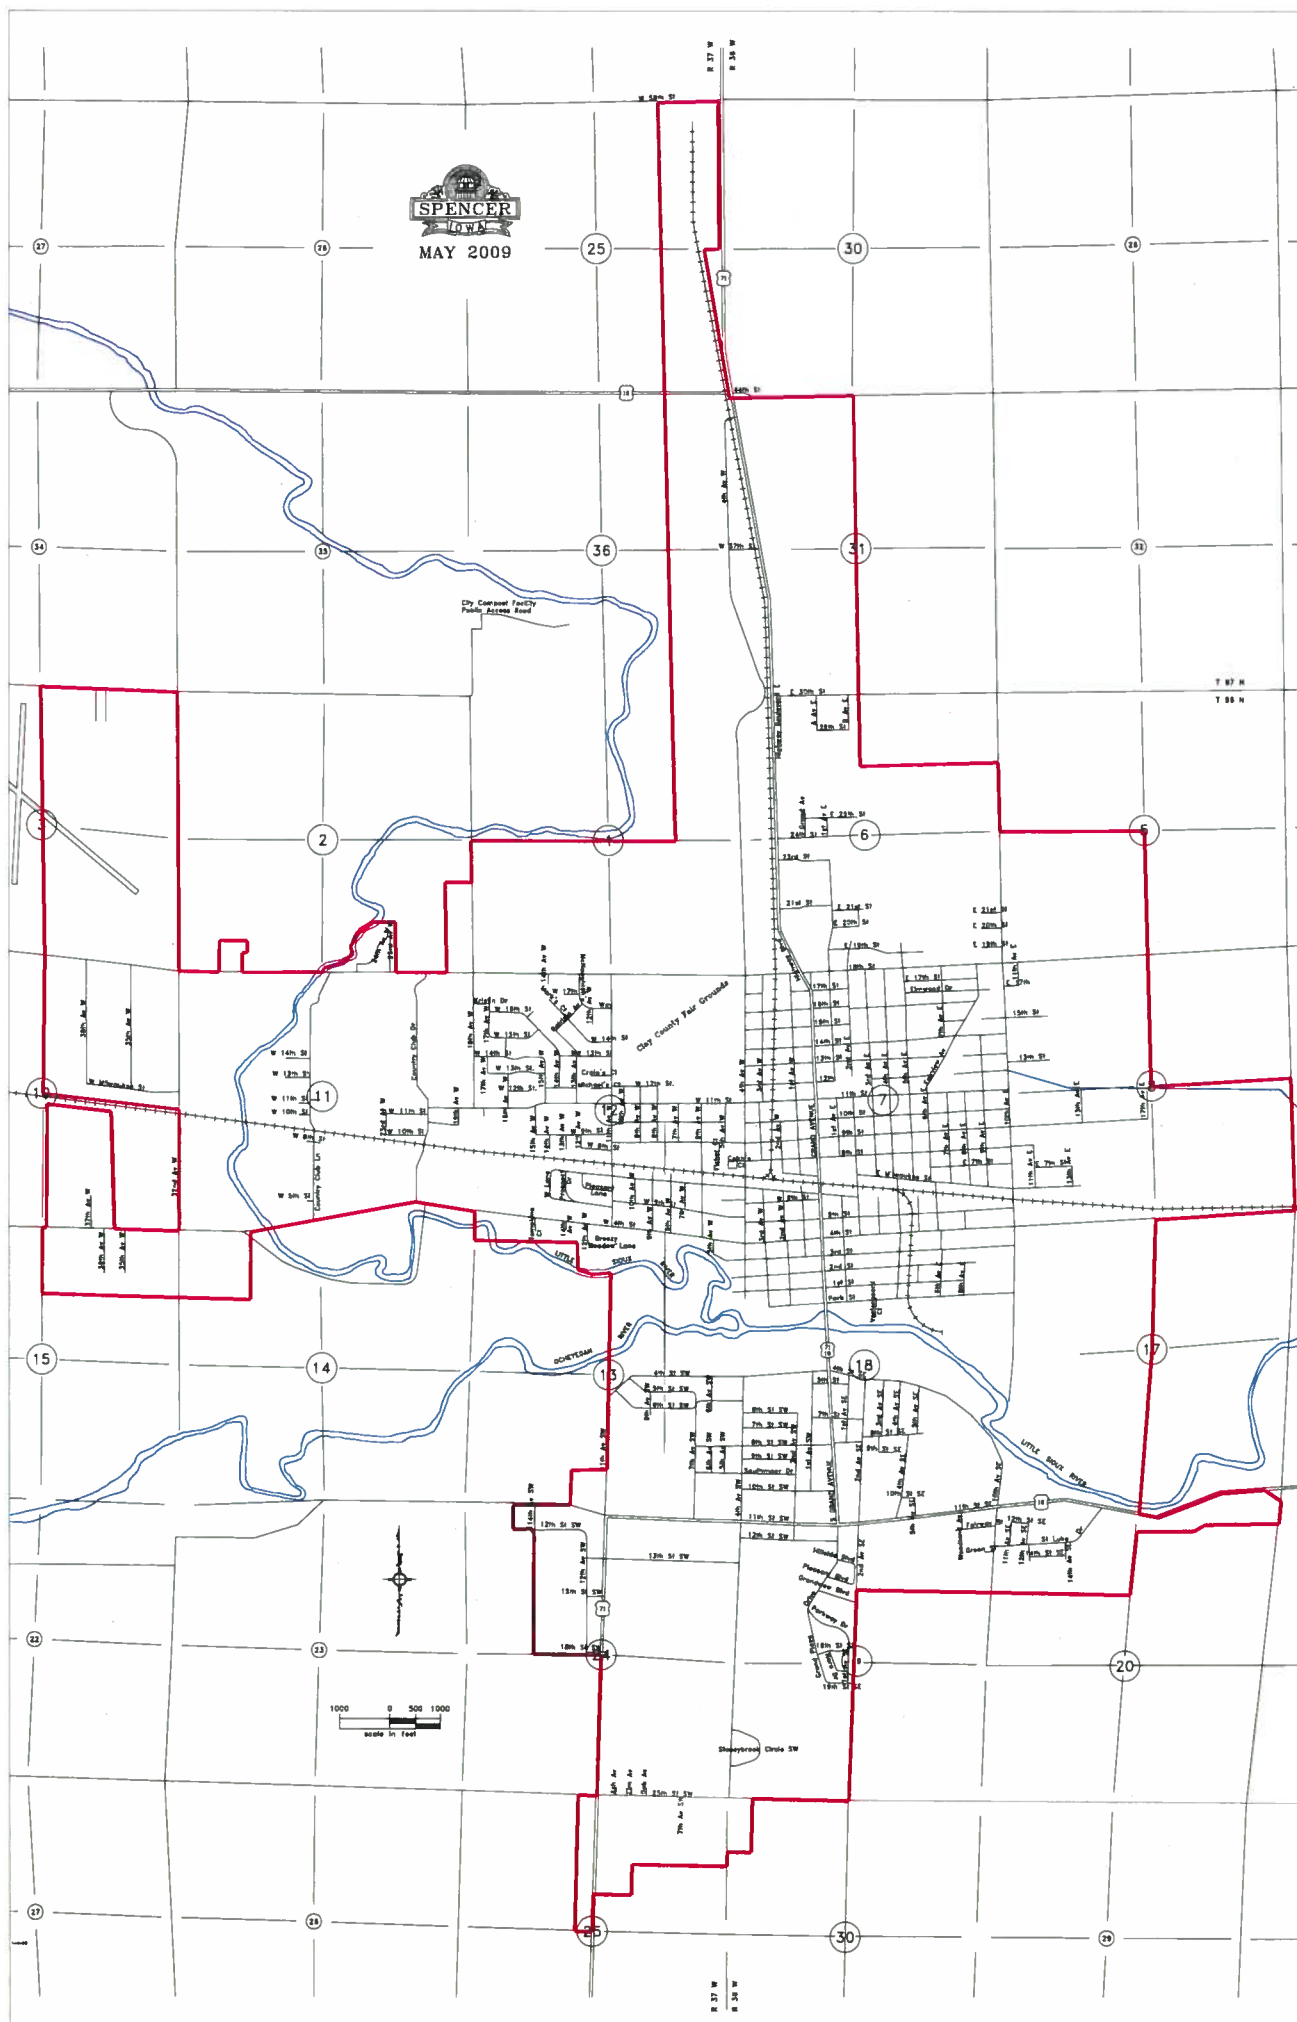
Pete's Pond

Outfall to river

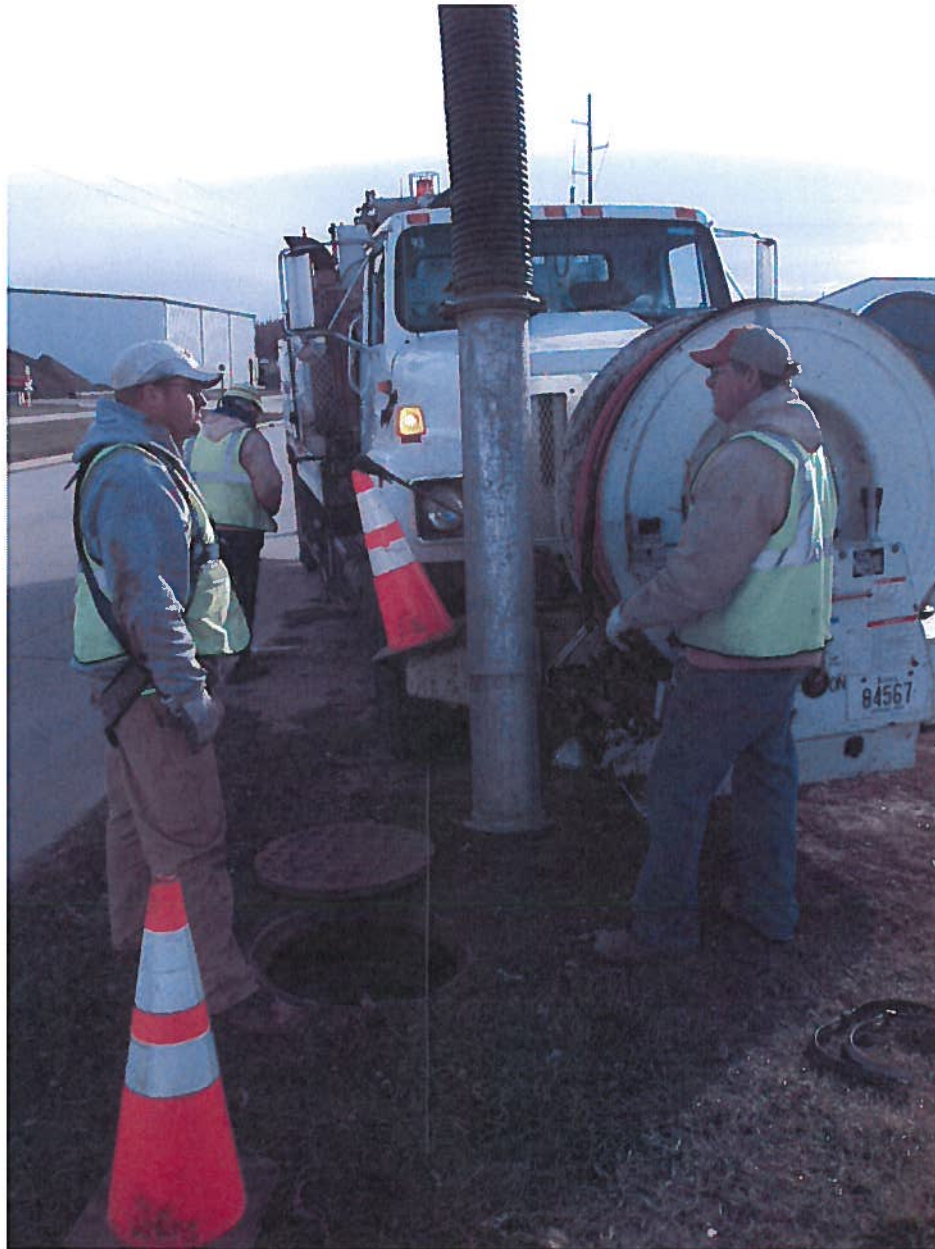
IDNR PHOTOGRAPH 11/20/2013 – CITY OF SPENCER STAFF WITH “JET TRUCK” PREPARING TO UNPLUG FLAP VALVE

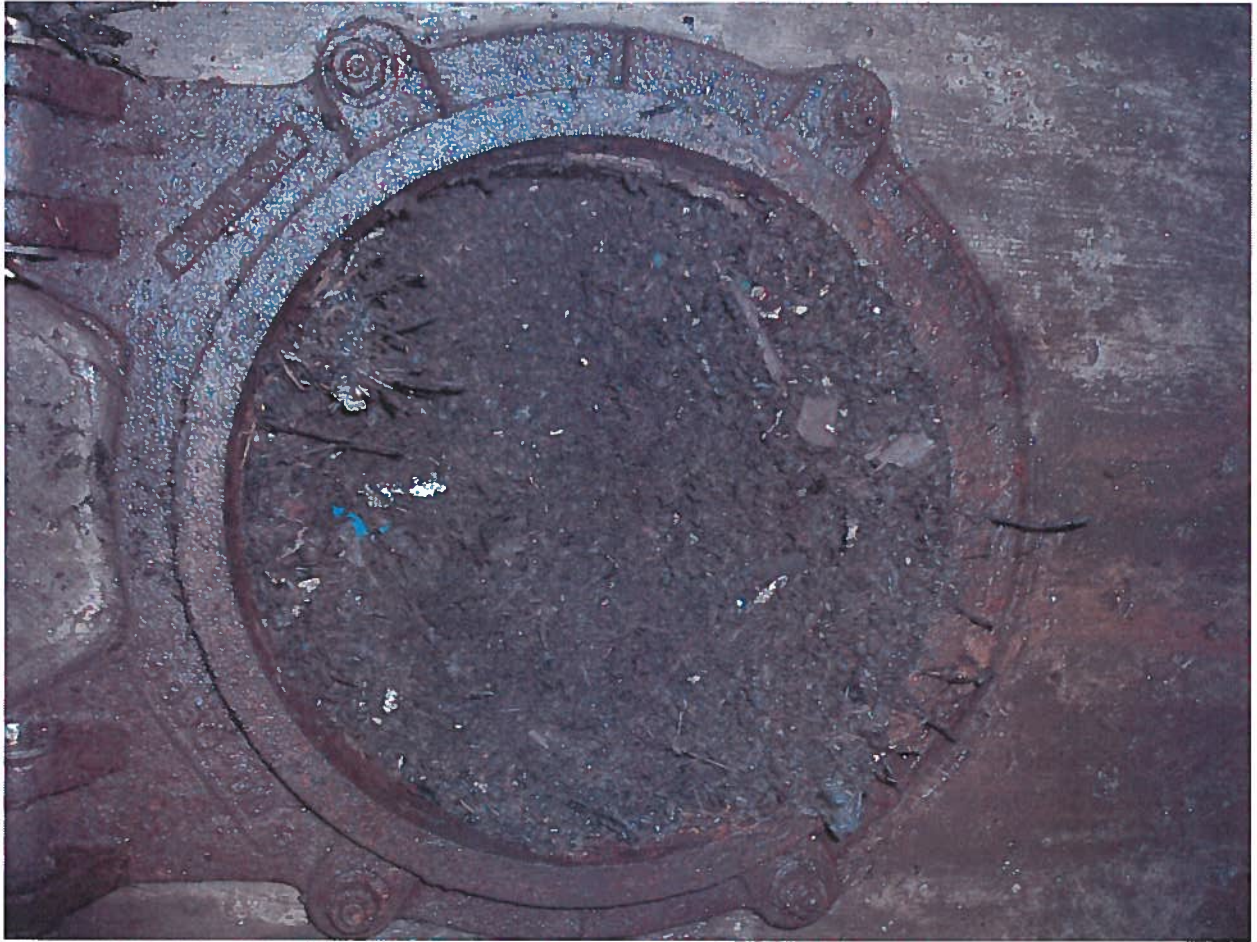
observed and Mr. Roos noted that the valve was stuck in the open position due to debris. Mr. Poulson stated that City staff would come back in the afternoon and unclog the line. Mr. Roos requested that he be notified prior to the City staff unclogging the line and that he be at the site when the work commenced. Mr. Poulson agreed and said that he would notify Mr. Roos.

IDNR PHOTOGRAPH 11/20/13 – PHOTOGRAPH OF STORM SEWER FLAP VALVE, LINE FROM PETE'S POND TO THE STORMSEWER. DEBRIS IN THE PIPE.

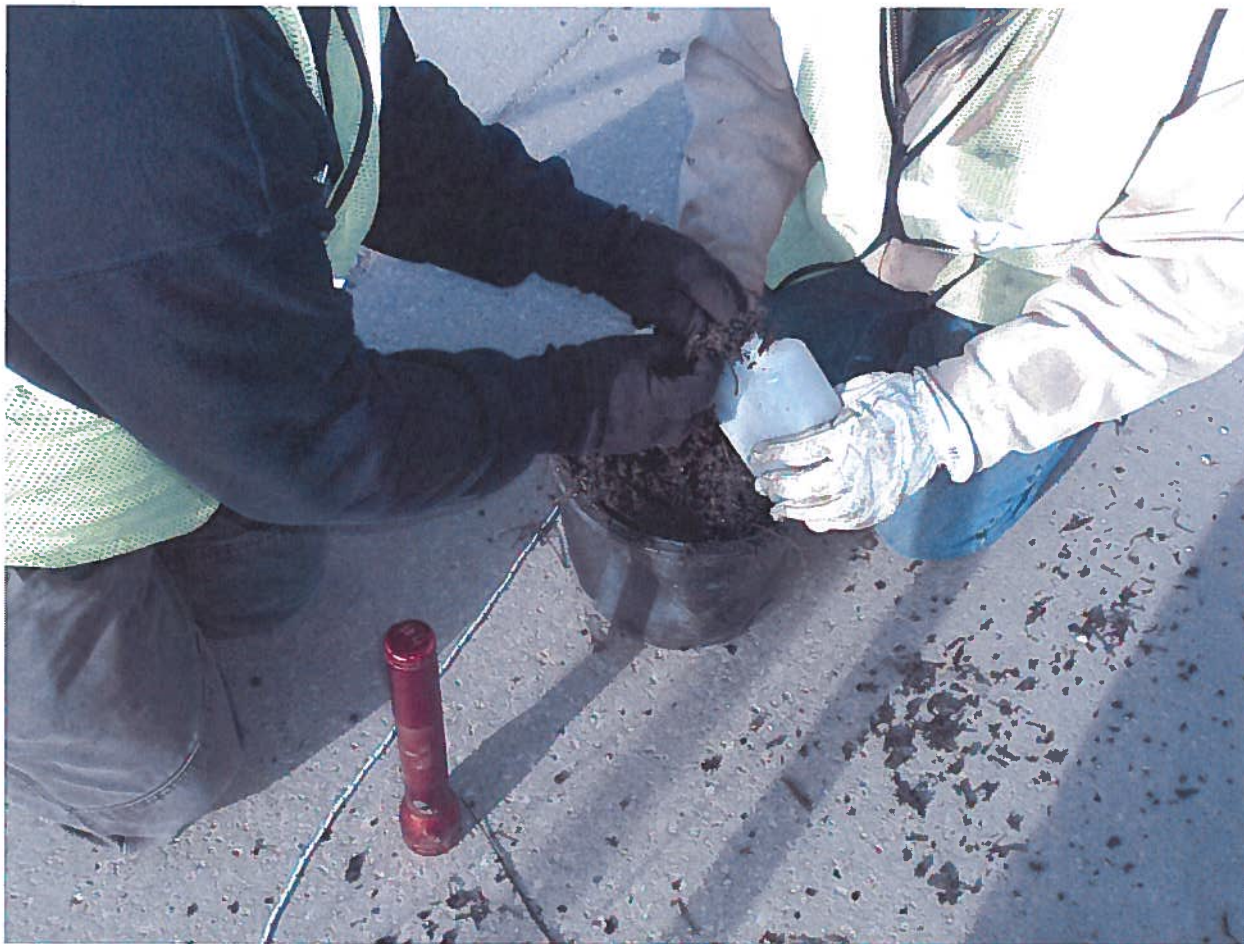
On November 21, 2013, Mr. Roos contacted me and informed me that he had been present when the City of Spencer Public Works Staff began working on unclogging the line from Pete's Pond to the 10<sup>th</sup> Avenue South East storm sewer. Mr. Roos explained that a sample of the material was collected and observed. He explained that the material was the same material noted in the flow path from the SBC facility to Pete's Pond. He also explained that there were actual pieces of metal wire mixed in the debris that measured up to 2 inches in length. Mr. Roos provided me with photographs that he had taken and they are included in this memorandum as Attachment #4.

IDNR PHOTOGRAPH 11/20/2013 – PHOTOGRAPH OF CITY OF SPENCER STAFF EVALUATING THE DEBRIS REMOVED FROM THE STORMSEWER AT THE FLAP VALVE
